PROPERTY INSPECTION REPORT

Address: **13 Broadbent St**
 Riccarton
 Christchurch

Date of report: **15th May 2015**

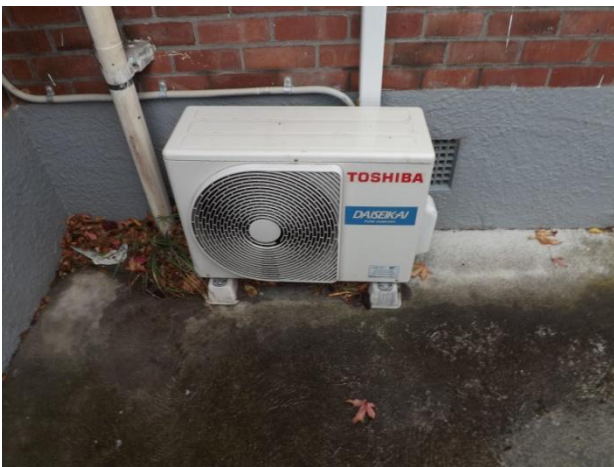
Exterior unit not secured to the base.

Insecure heat-pump.

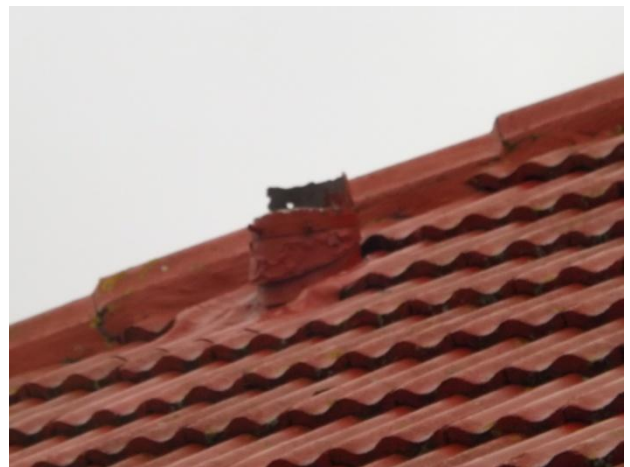
Old metal chimney flue has been removed; hole remains open to the weather on the roof.

Hole in roof from previous chimney.

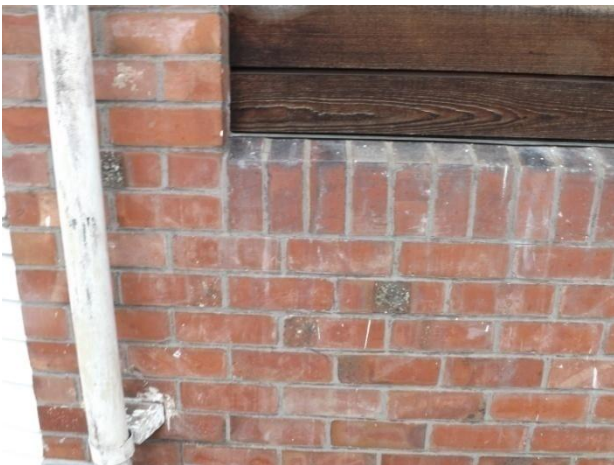
100 Series brick cladding; minor cracking to mortar-joints, otherwise in good condition.

Very minor cracking to mortar-joints.

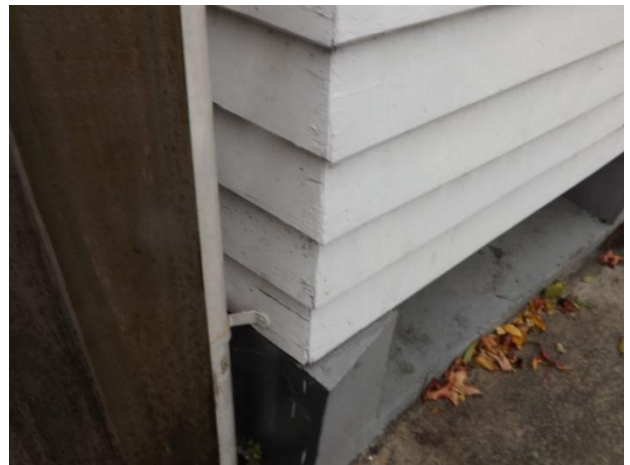
Deterioration/rot to the timber weather-boards to the extension, also evidence of borer.

Borer to weather-boards.

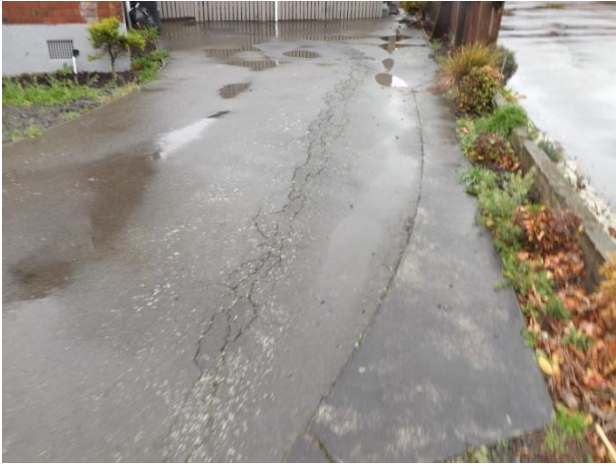
Slumping to the edges of the tar-seal.

Slumping to tar-sealed driveway.

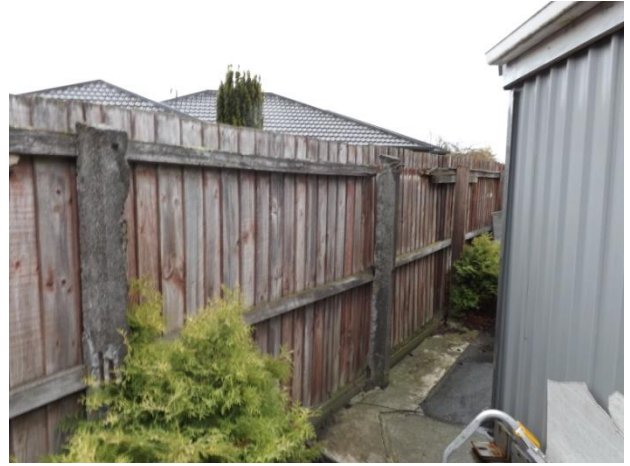
Deterioration/rot to the rails on the south elevation fencing.

Deteriorating fence rails.

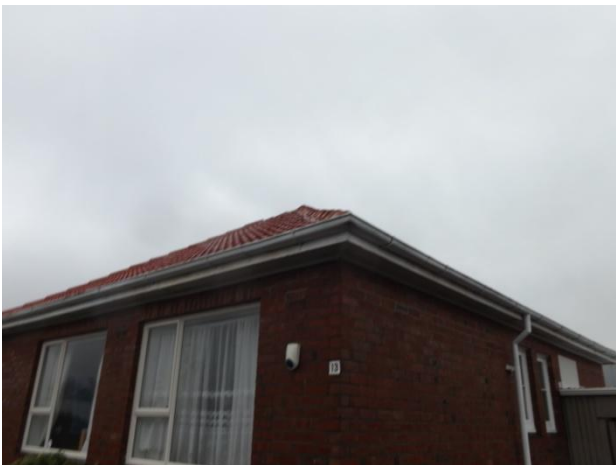
Concrete tile roofing to the original part of the house has slight sagging to the hip-blades due to weight of roof and age of house, otherwise appears to be in good order.

South/east hip blade is sagging.

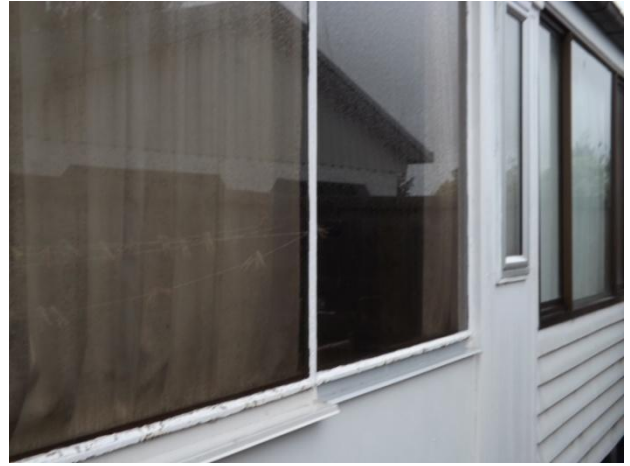
Minor rust to the steel window.

Two bedroom extension to east.
Steel window beginning to rust.

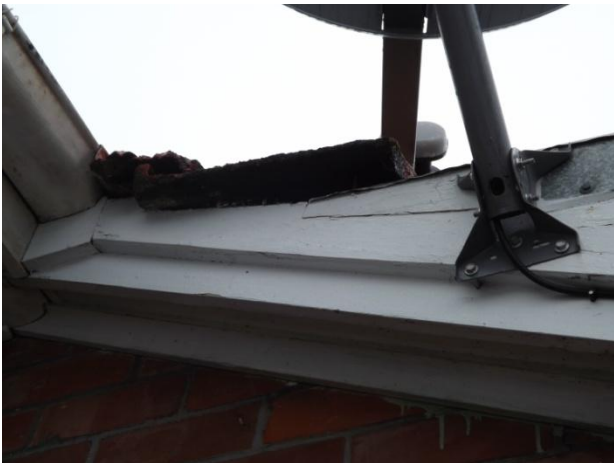
Timber fascia and barges mostly in good condition; hole to the south elevation barge.

Hole in barge capping may allow south/
west rain inside.

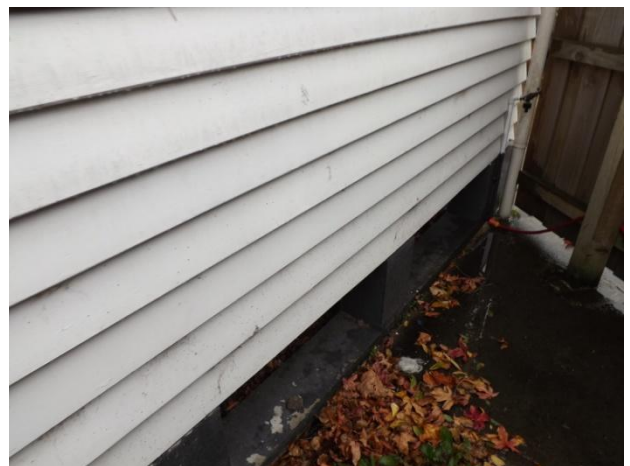
Borer to cladding.

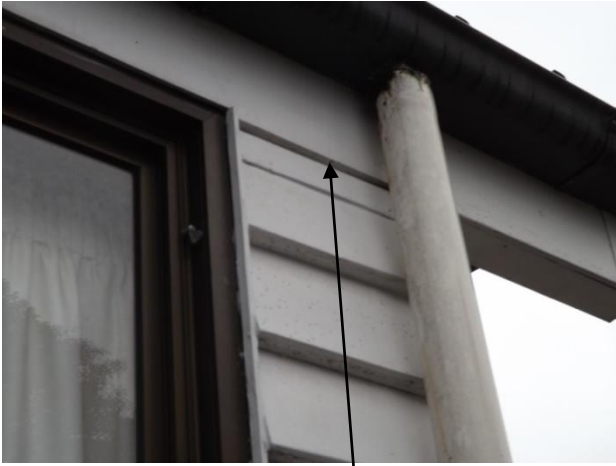
Narrow gap to the top of the weatherboards on the north/east corner.

Small hole to cladding.

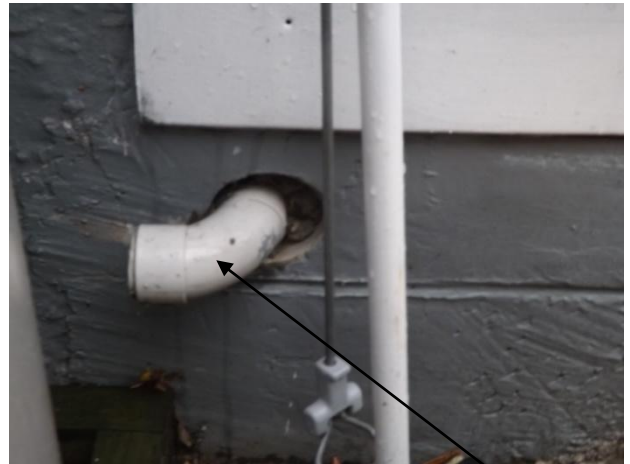
Unsure where one waste-pipe on the exterior of the extension is from as it does not go to a sewer outlet.

Not sure what this waste-pipe is for.

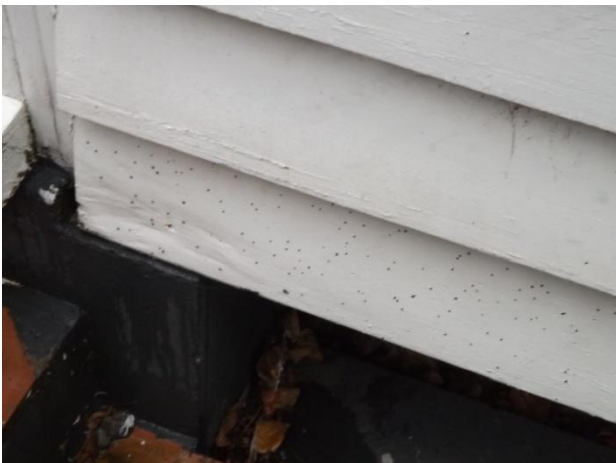
Rotten board and borer to east elevation.

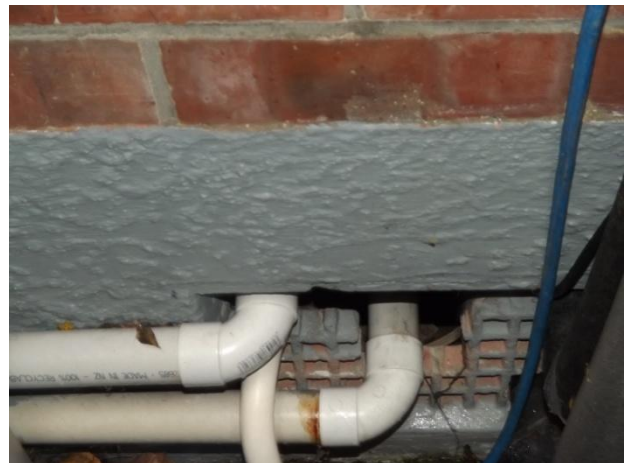
Holes around waste-pipes should be plastered.

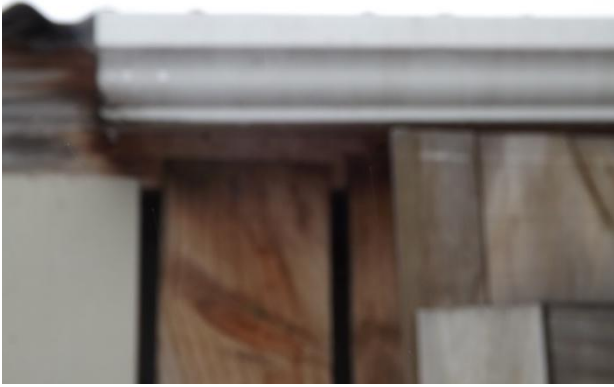
Water runs off the end of the lean-to roofing spouting.

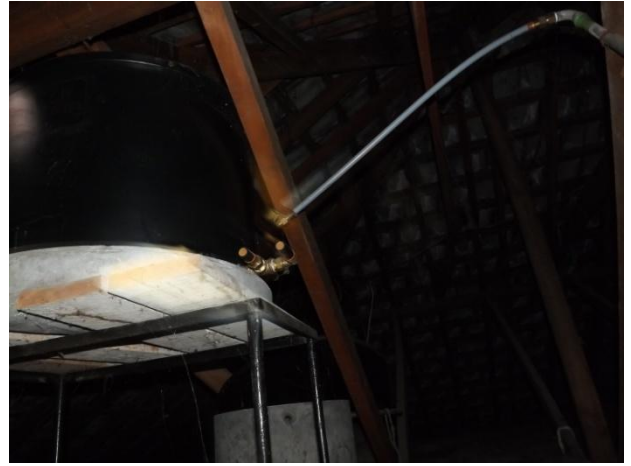
Polyurethane tank not secured in roof-space; no longer in use.

Water-tank in roof-space not secured.

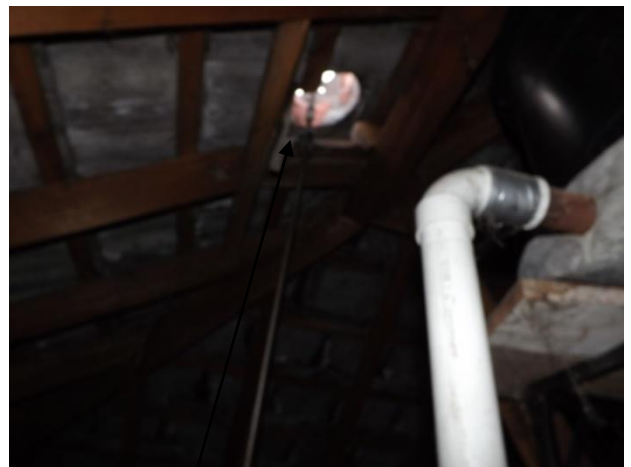
Hole in roof from previous chimney flue.

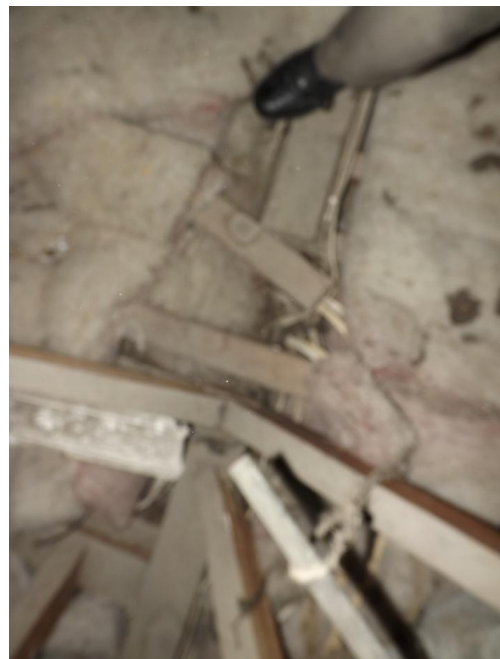
Mostly Thermoplastic-sheathed cable wiring (TPS).
Cloth wirings to the mains-cable.

Mostly TPS wiring to ceiling.

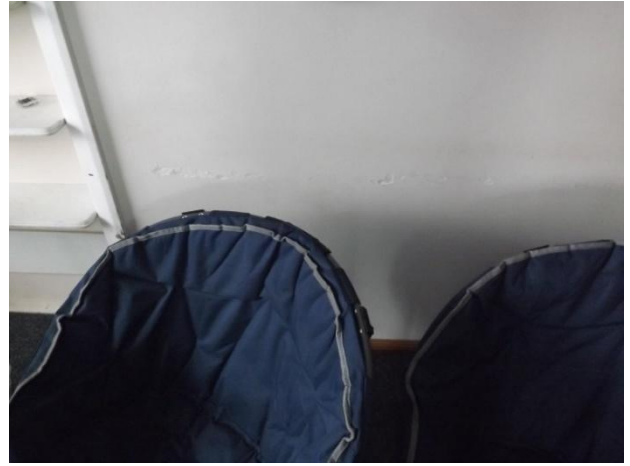
Some dents to the plaster walls; balance in good condition.
Partition wall has been removed and a beam placed in the ceiling; all well-built.

Dents in wall of lounge.

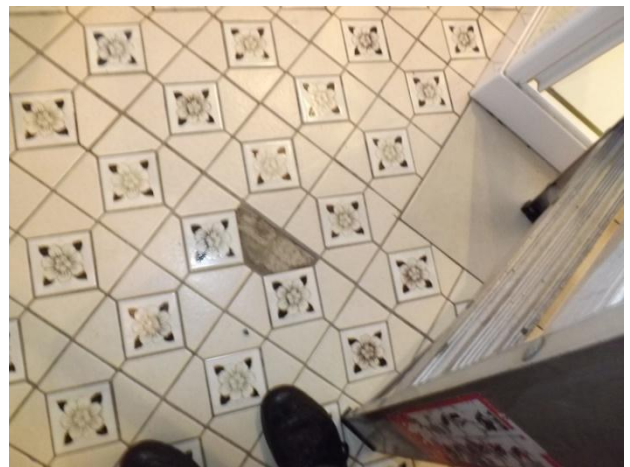
Two tiles are missing.

Tiles missing to bathroom floor.

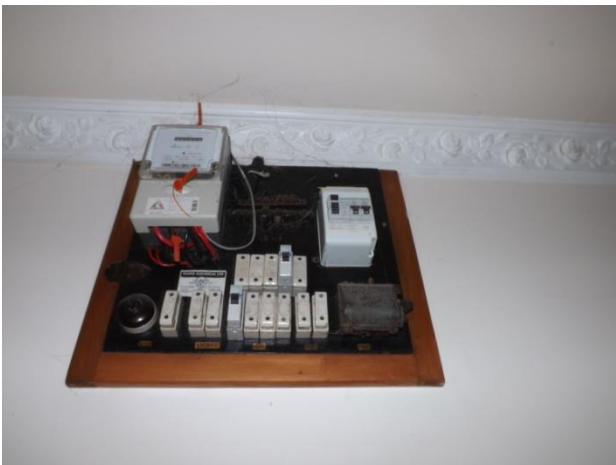
Switchboard in good condition; two MCB's added.
Cloth wirings to the mains-cable.

Switch board in good order; cloth mains cable.

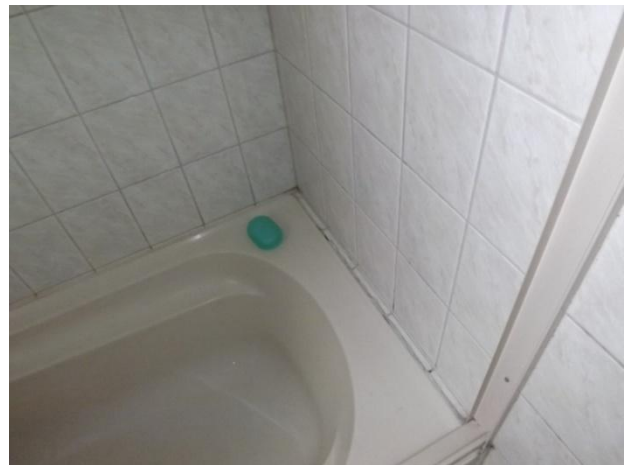
The end of the bath requires re-sealing.

Sealant required to end of bath.

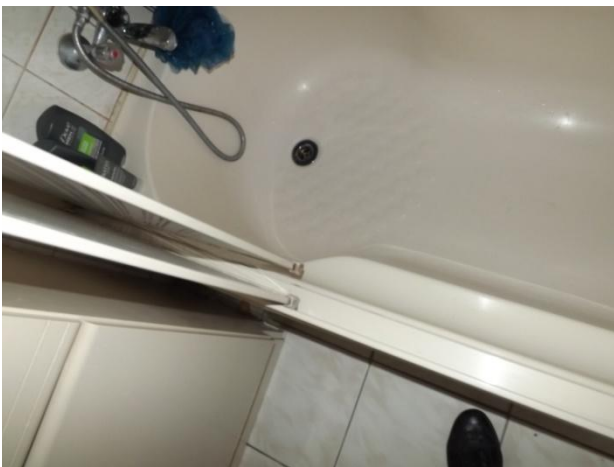
Screen doors are not working correctly on the track.

Screen-doors to bath not operating correctly.

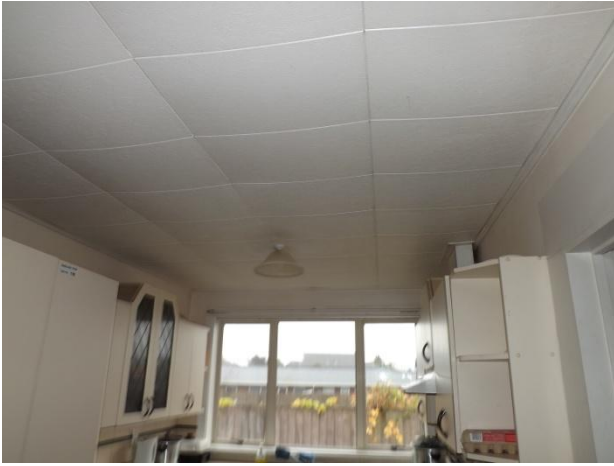
Plaster walls in good condition; no visible cracking.
Hard-board tiles to the ceiling are sagging in places.

Kitchen ceiling tiles are sagging.

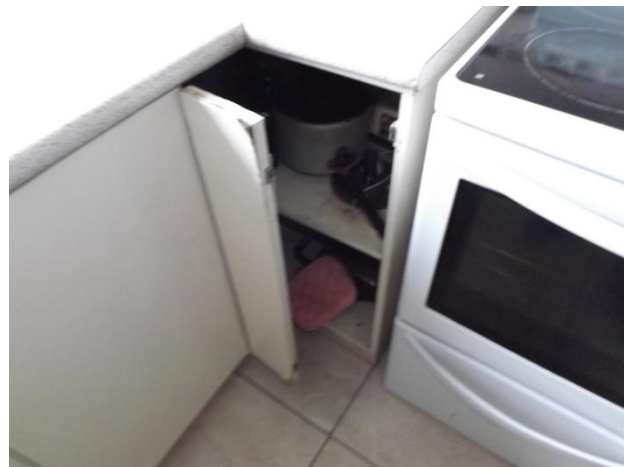
Melamine cabinetry has tape missing to the edges, also some water-damage.
Drawers are tight to open; need easing.
One cupboard door is broken/missing.

Loose door to kitchen units.

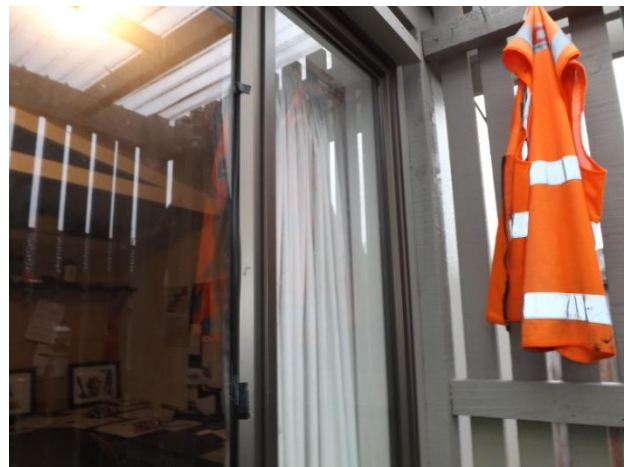
Beads to the fixed window pane beside the door are loose.

Loose beads to window sash in the south bedroom.

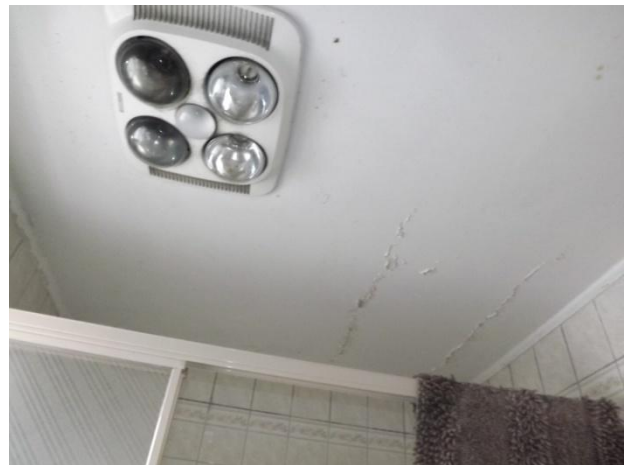
Plaster to the ceiling is in poor/water-damaged condition.

Paint deteriorating to bathroom ceiling.
